**Draft Report
Project No. 60251**

**Volume 1 of 5
Remedial Investigation Report
ACS NPL Site
Griffith, Indiana**

**REMEDIAL INVESTIGATION REPORT
AMERICAN CHEMICAL SERVICES NPL SITE
GRIFFITH, INDIANA**

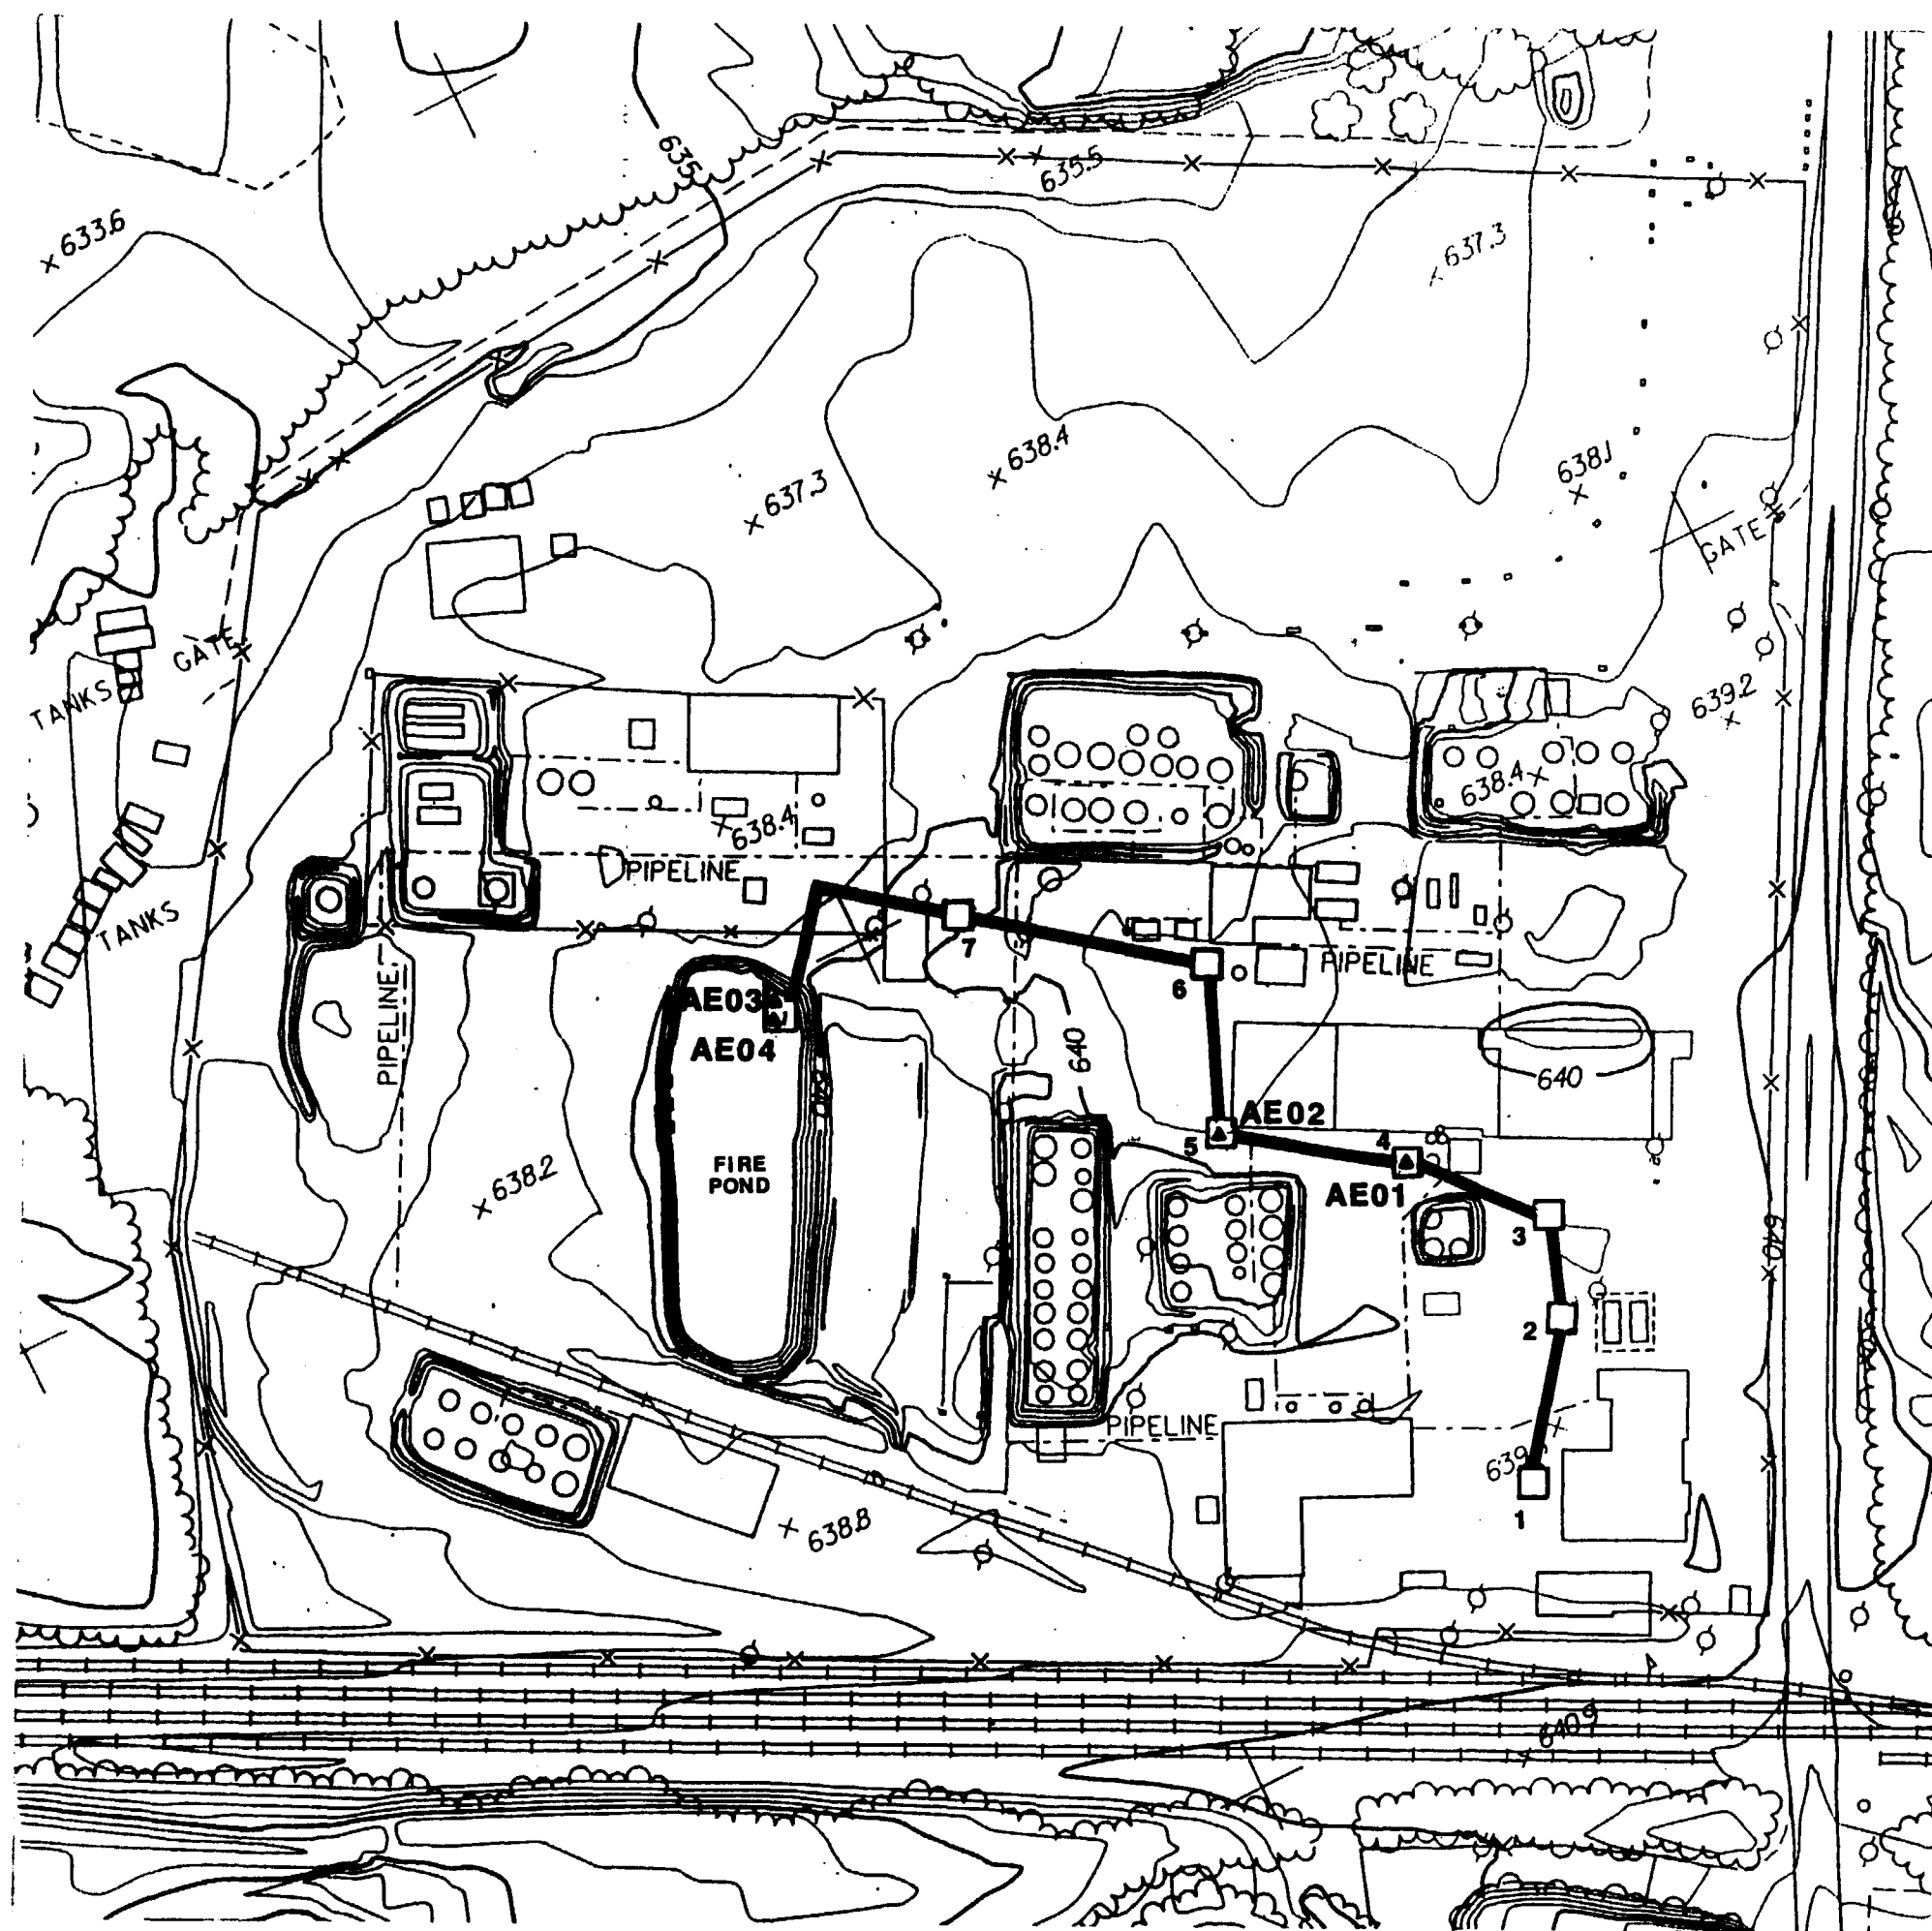
FIGURE 4-20

1. AT SAMPLING LOCATION AE01 SAMPLE WAS COLLECTED FROM 7' OF WATER FOUND IN CATCH BASIN.
2. AT SAMPLE LOCATION AE02 SAMPLE WAS COLLECTED FROM 5.5' OF WATER FOUND IN CATCH BASIN.
3. AT SAMPLE LOCATION AE03, SAMPLE WAS COLLECTED BY SKIMMING WATER OFF THE SURFACE.
4. AT SAMPLE LOCATION AE04 SAMPLE WAS COLLECTED FROM THE BOTTOM OF CATCH BASIN (16" DEEP).
5. EFFLUENT SAMPLING WAS CONDUCTED BY WARZYN ENGINEERING INC. ON NOVEMBER 15, 1989.
6. INITIAL BASE MAP WAS DEVELOPED FOR CAMP DRESSER & McKEE INC. ON NOVEMBER 8, 1985. MAP HAS BEEN UPDATED FROM AN AERIAL PHOTOGRAPH OF THE SITE FLOWN ON NOVEMBER 3, 1989 BY GEONEX CHICAGO AERIAL SURVEY, INC. THE BASE MAP WAS UPDATED BASED ON THE AERIAL PHOTOGRAPH BY GEONEX.

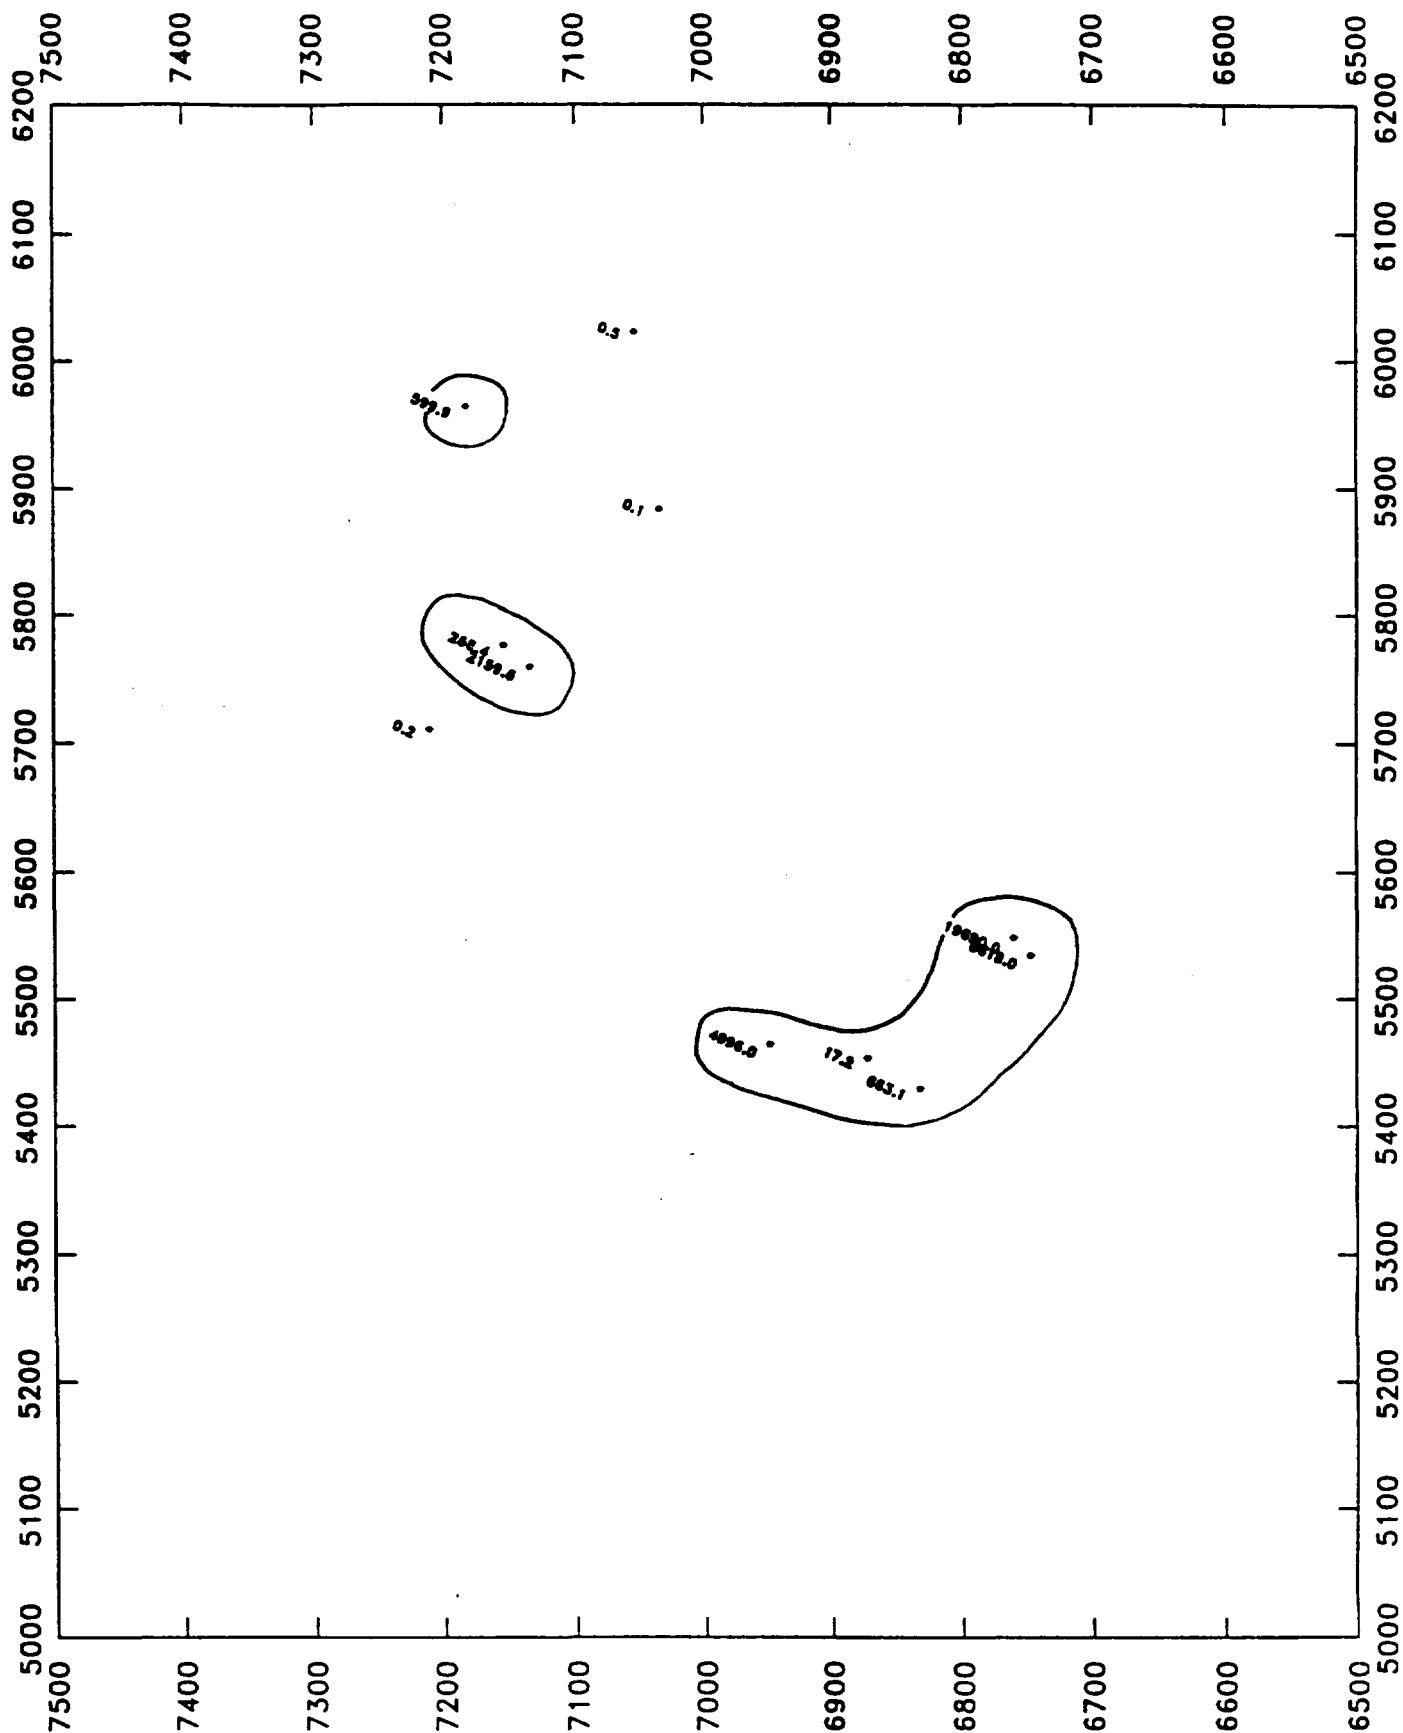
Figure 5-6b Approximate Extent of Total Volatile Wastes (> 1 ppm), On-Site Areas (4-7 feet below surface). Posted Values are in ppm (mg/kg).

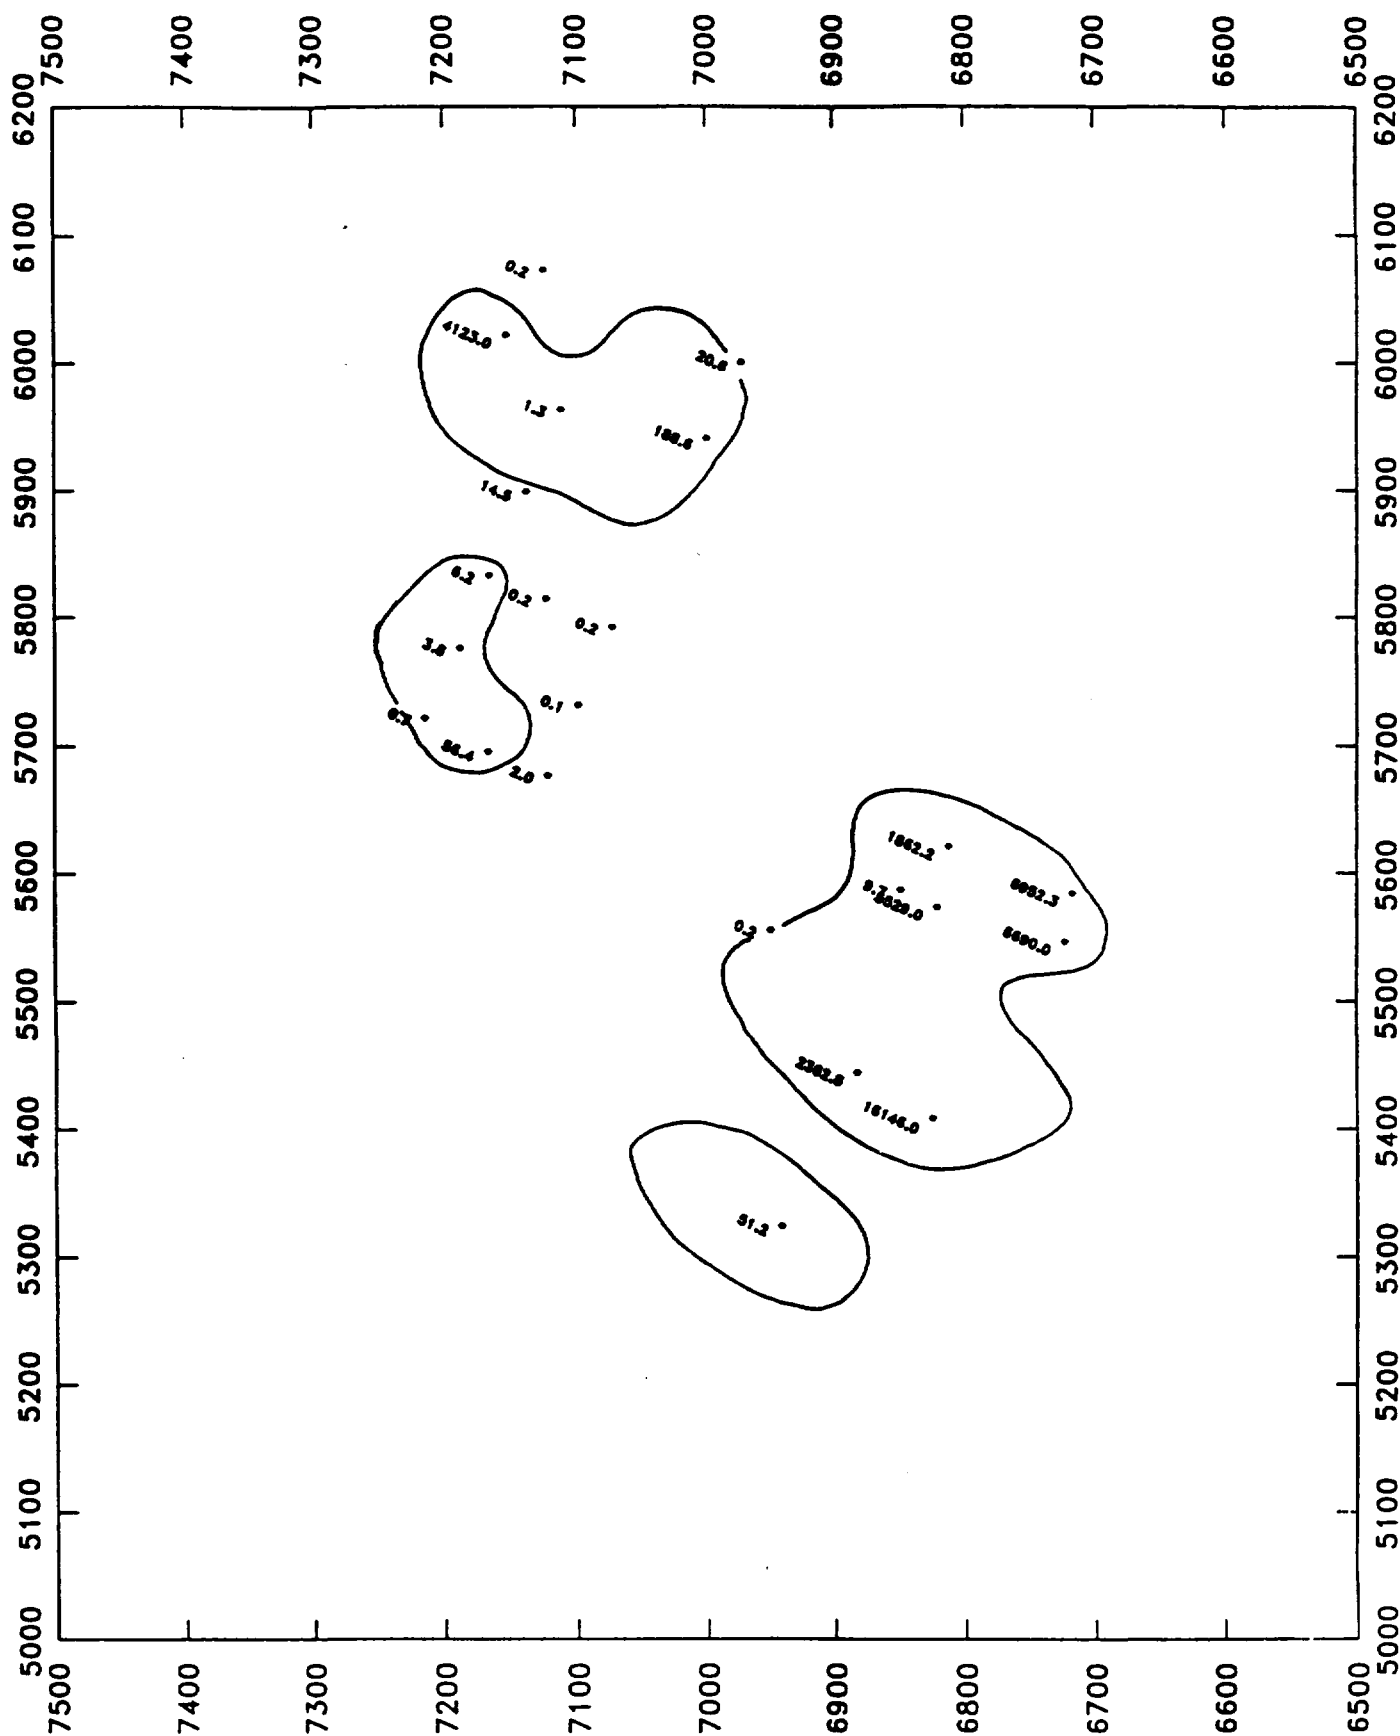
Figure 5-6c Approximate Extent of Total Volatile Wastes (> 1 ppm), On-Site Areas 7-9 feet below surface). Posted Values are in ppm (mg/kg).

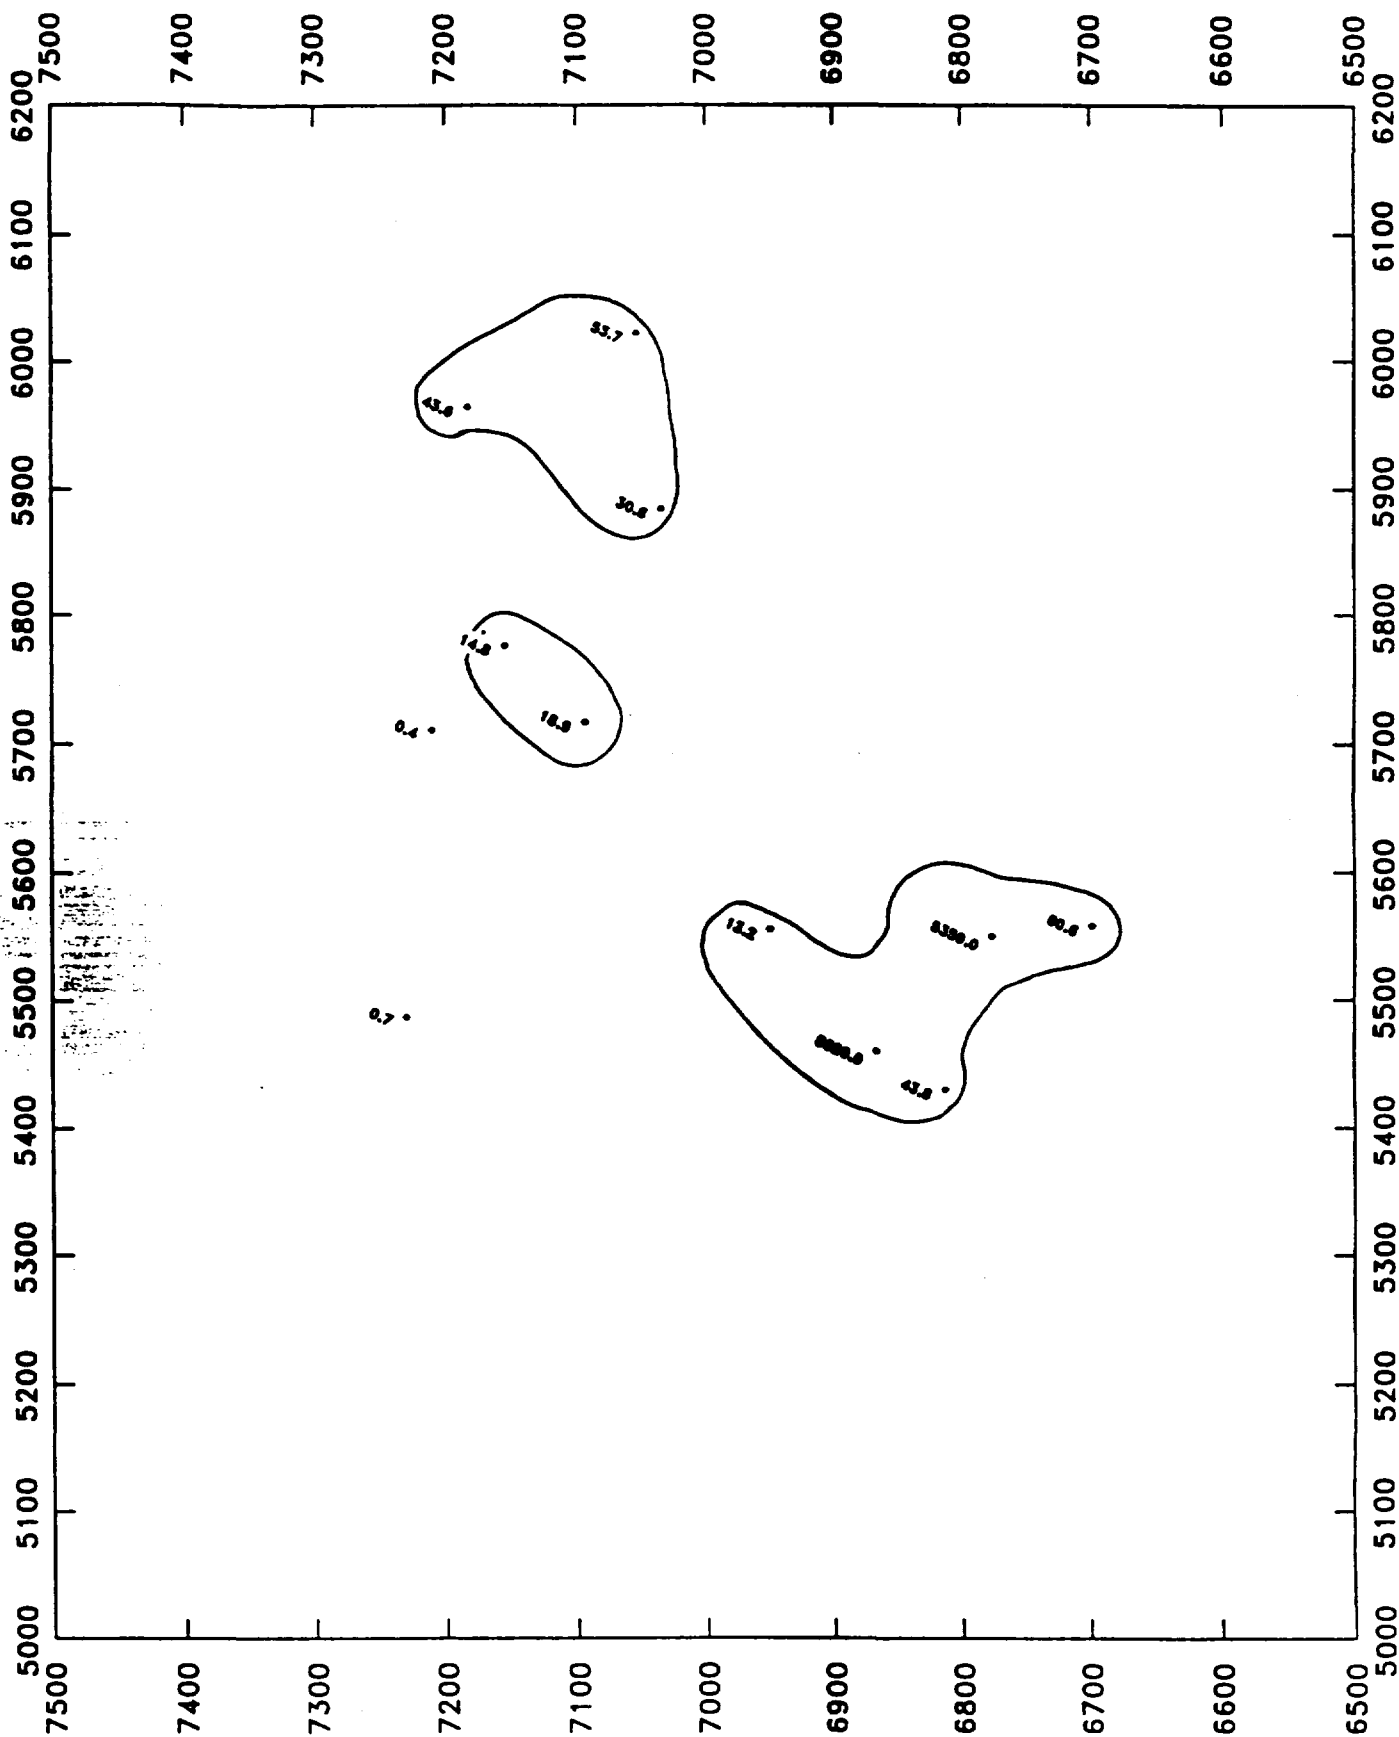
Figure 5-6d Approximate Extent of Total Volatile Wastes (> 1 ppm), On-Site Areas (9-14 feet below surface). Posted Values are in ppm (mg/kg).

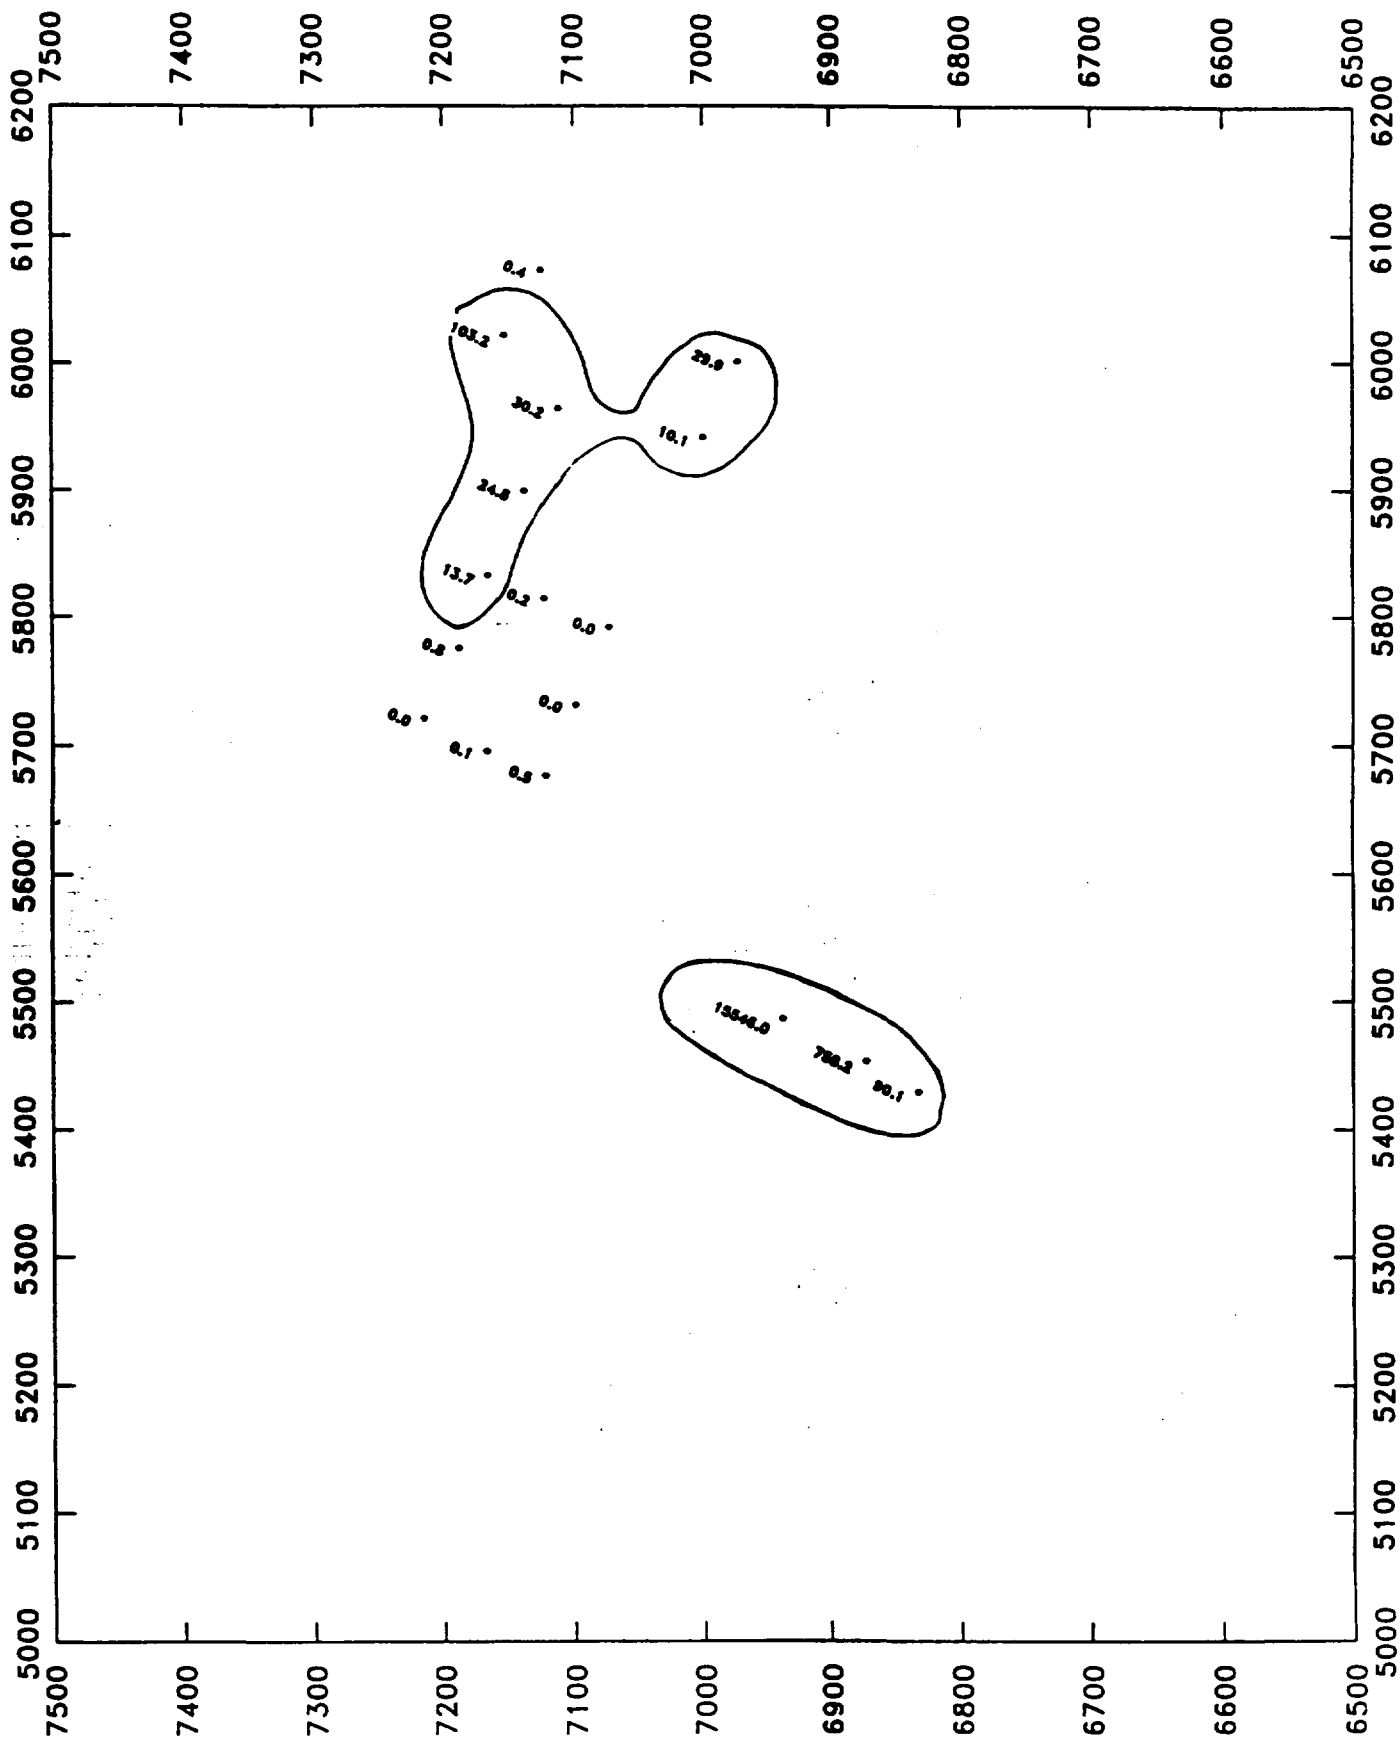
Figure 5-6e Approximate Extent of Total Volatile Wastes (> 1 ppm), On-Site Areas (14-19 feet below surface). Posted Values are in ppm (mg/kg).

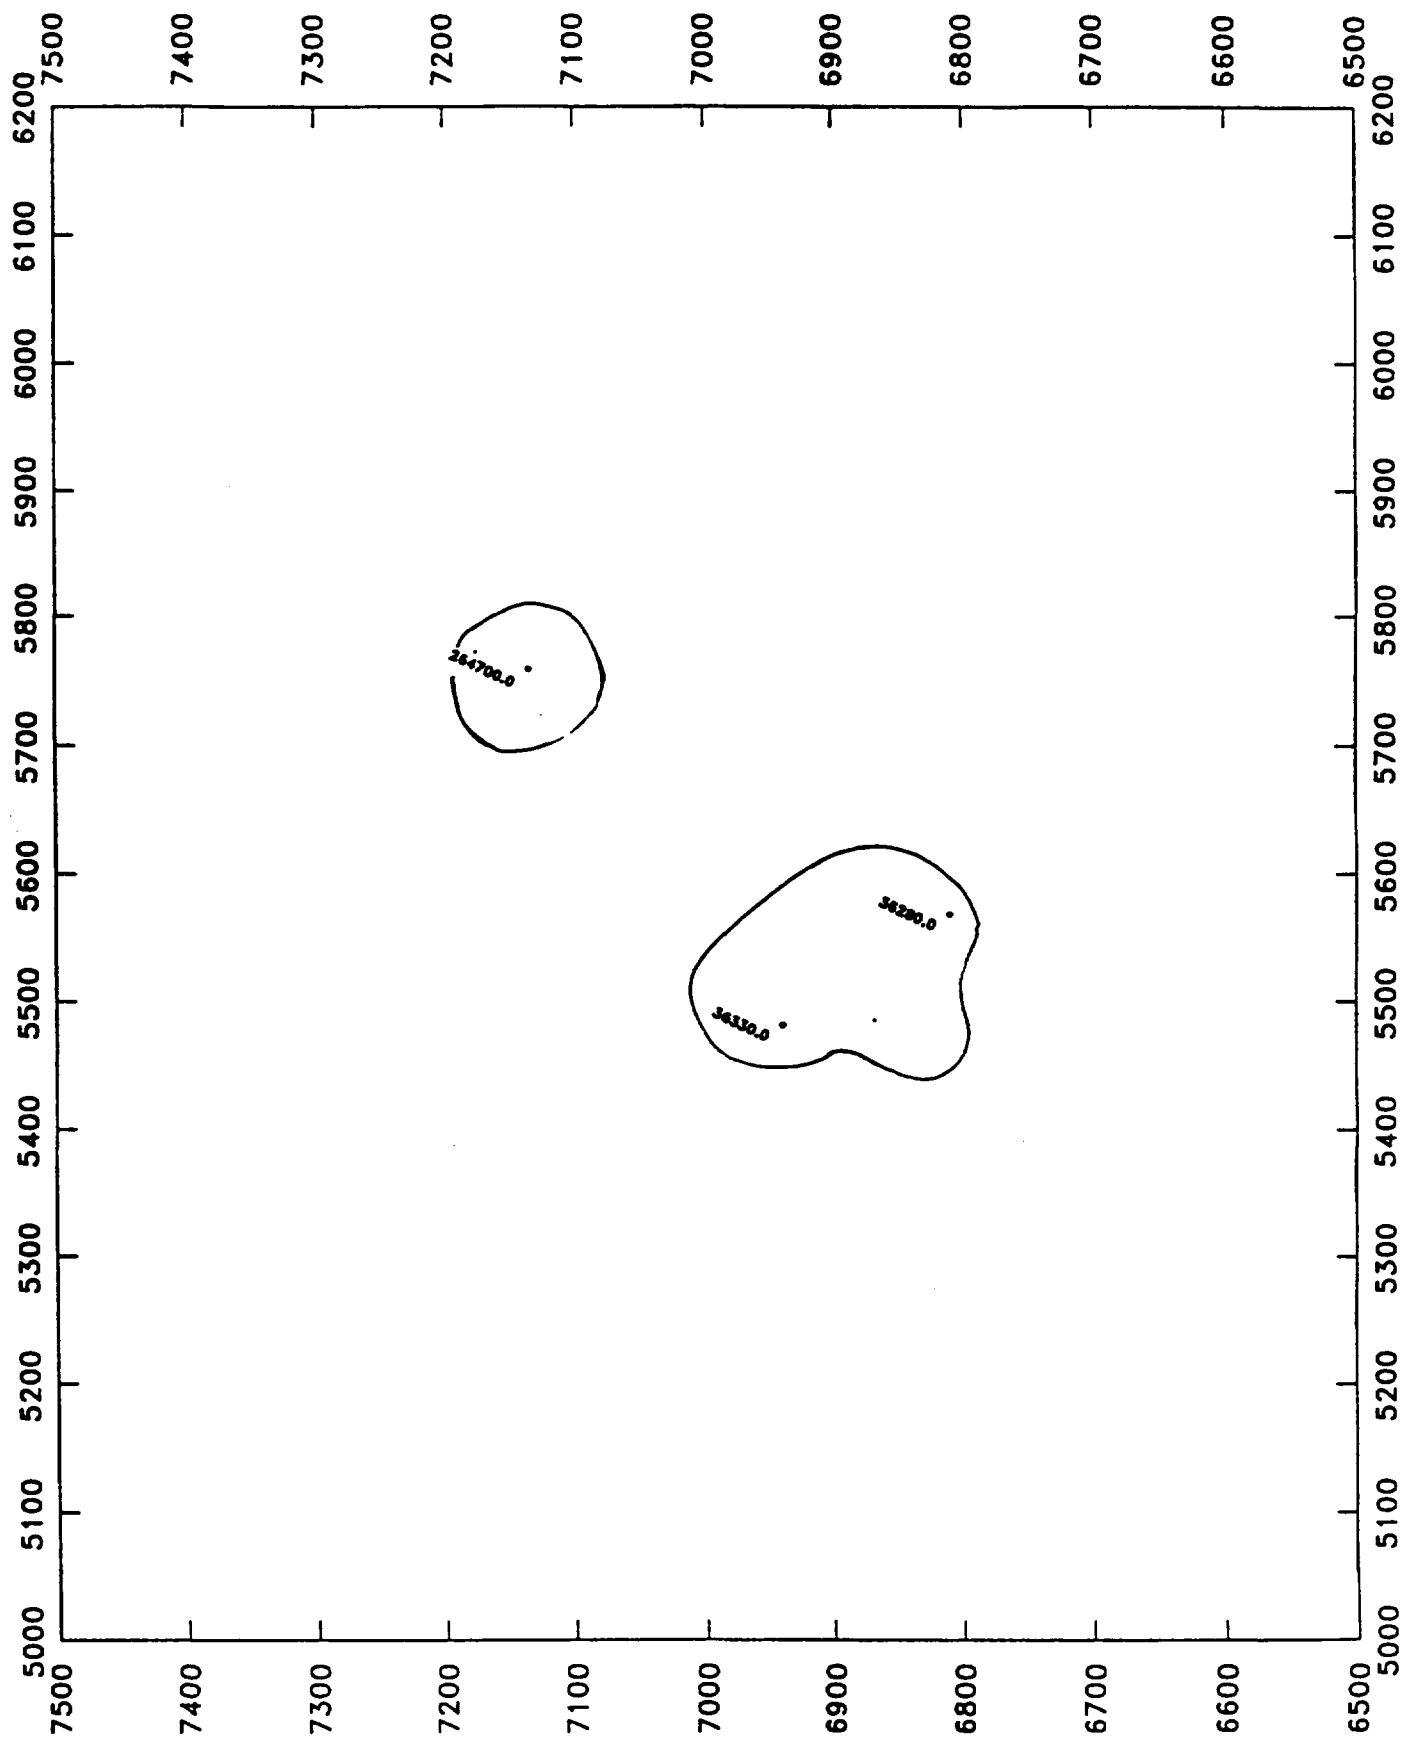
Figure 5-6a Approximate Extent of Total Volatile Wastes (> 1 ppm), On-Site Areas (1-4 feet below surface). Posted Values are in ppm (mg/kg).

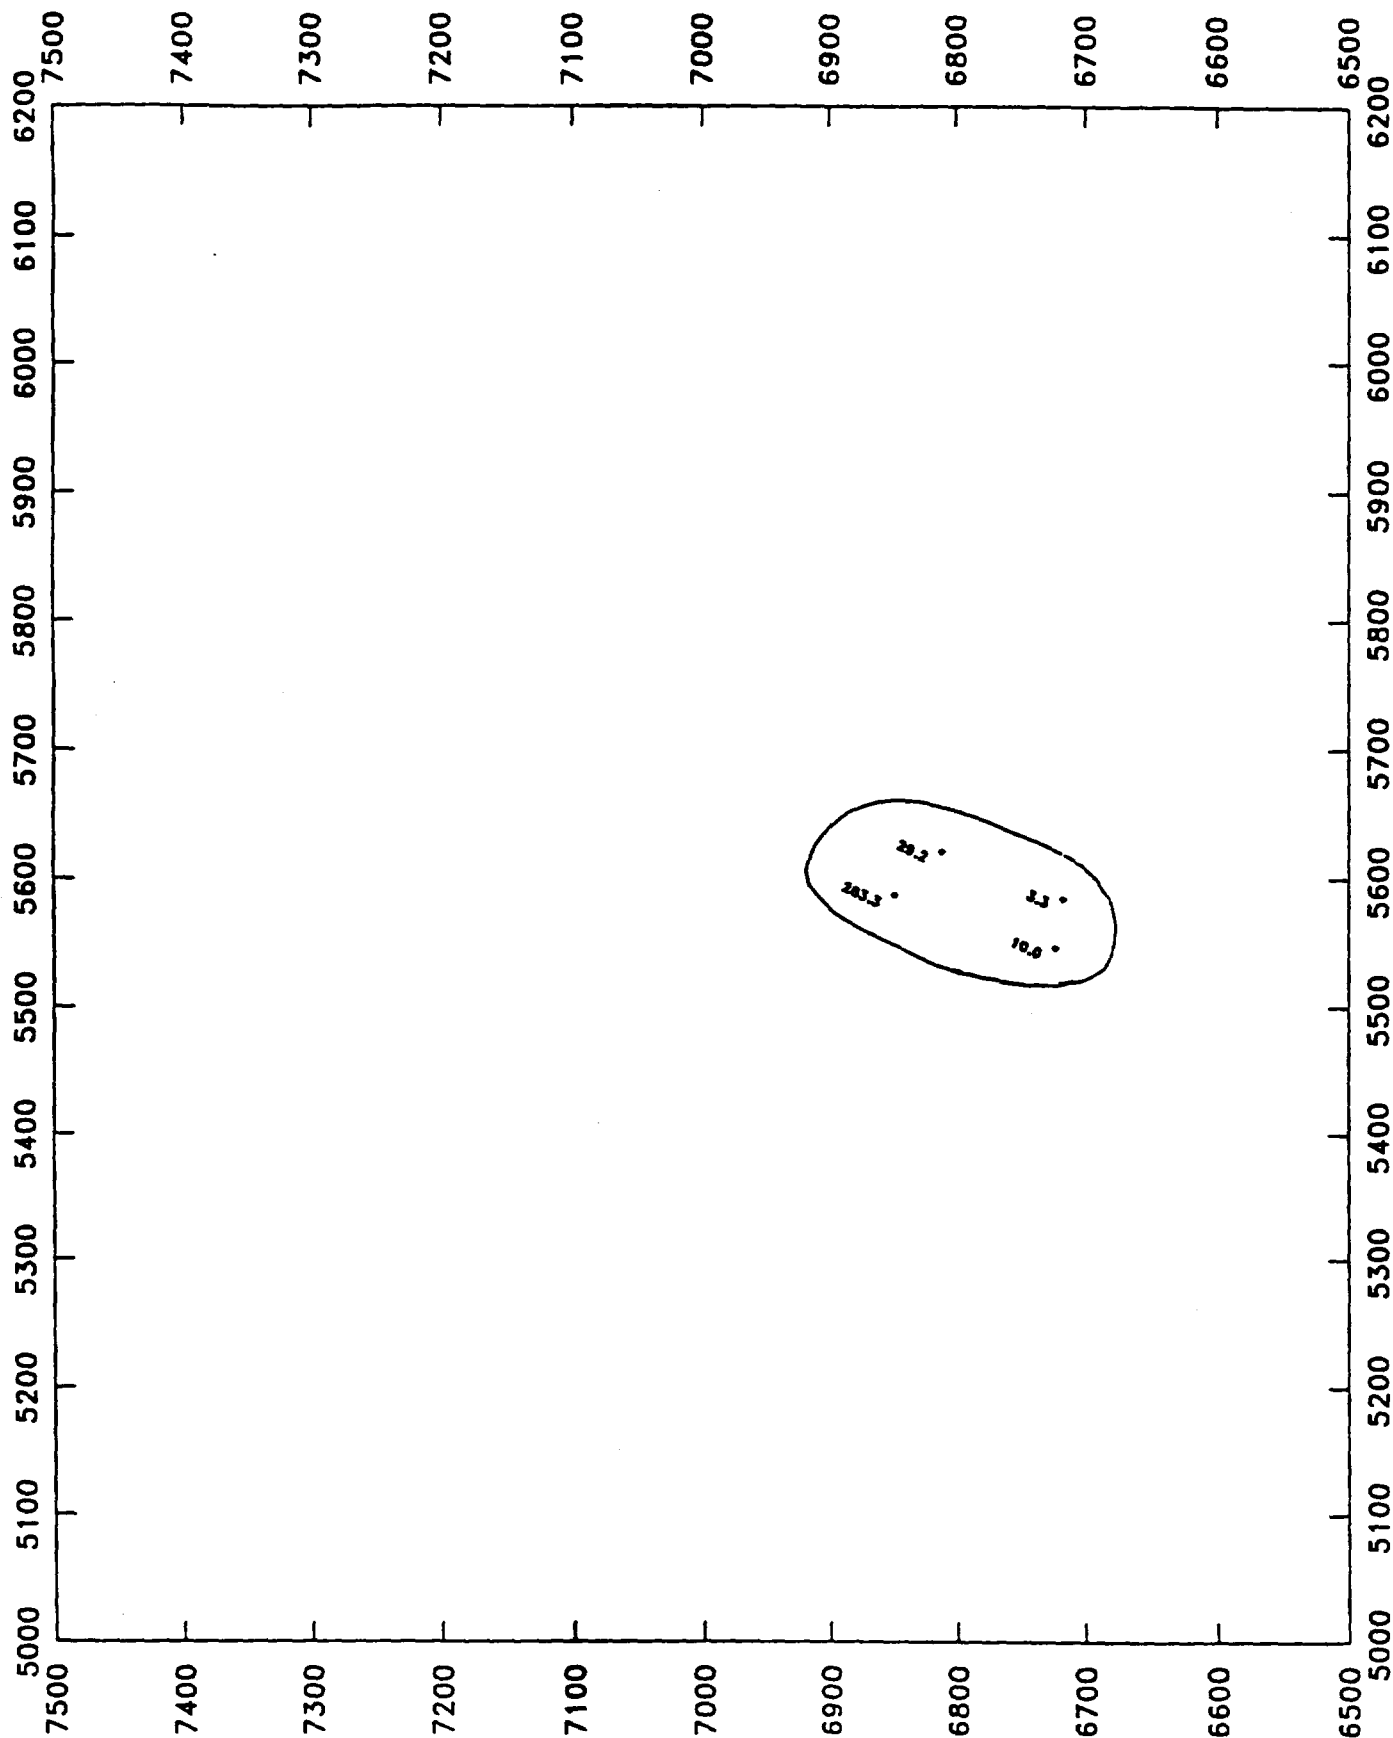
Figure 5-6f Approximate Extent of Total Volatile Wastes (> 1 ppm), On-Site Areas 19-24 feet below surface). Posted Values are in ppm (mg/kg).

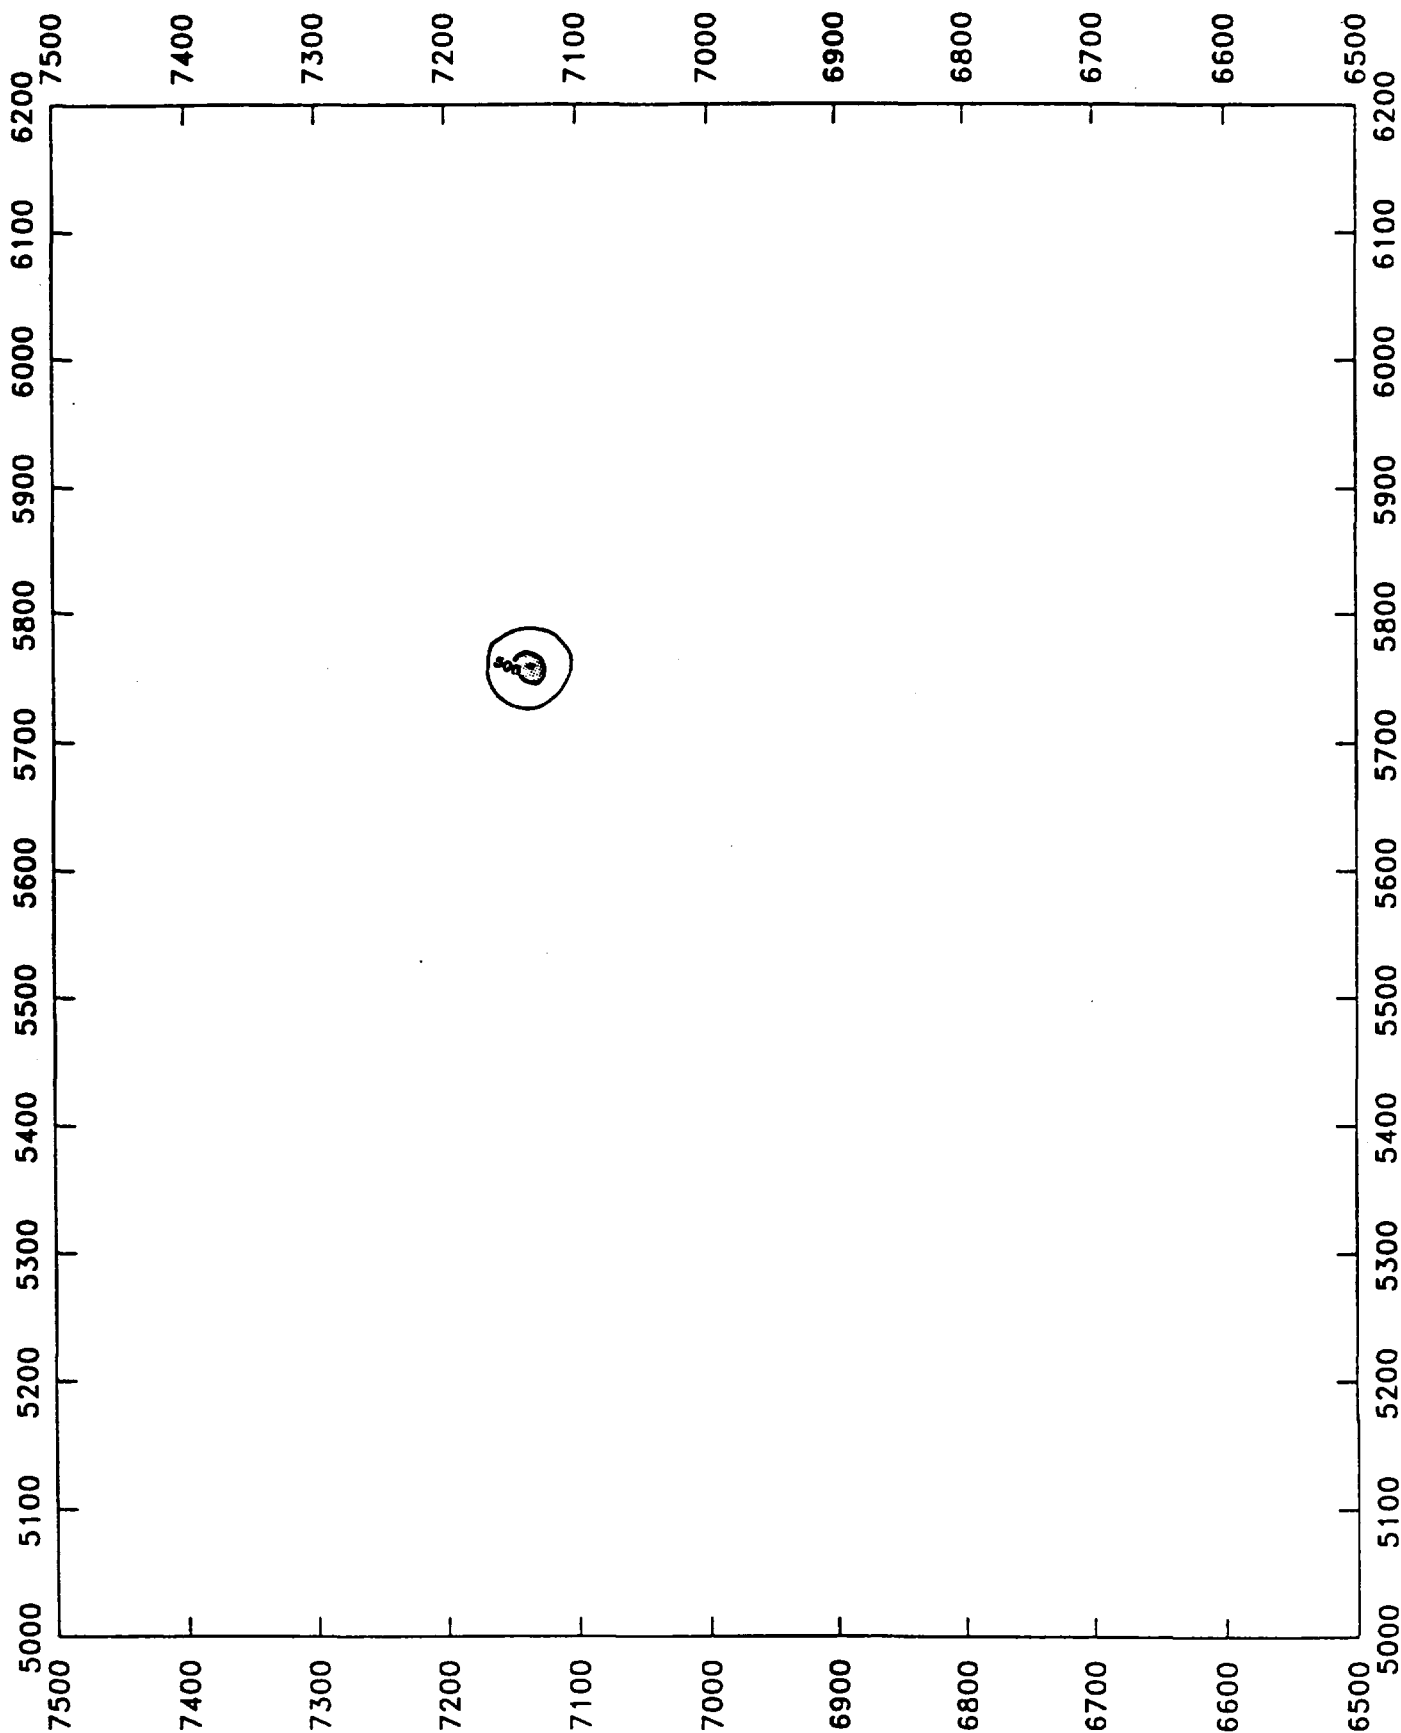
Figure 5-7a Approximate Extent of Total PCB Containing Wastes (> 1 ppm, shaded > 50 ppm), On-Site Areas (1-3 feet below surface)
